Radar-Based Train Detection on Diamond Crossover Structures

Final Report
V 1.1

ByStep, LLC
June 23, 2013

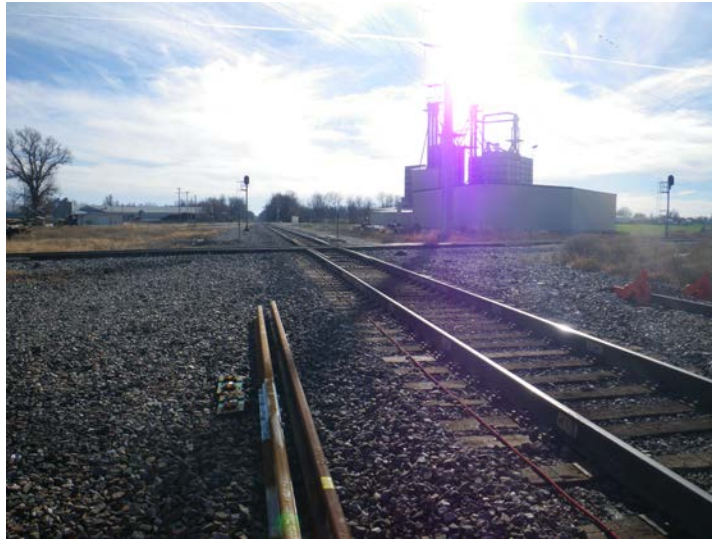
Figure 1 - The BNSF-MNA Crossover at Lamar Missouri

The test site is located in Lamar Missouri, northeast of Springfield Missouri in BNSF’s Fort Scott Subdivision. There a north-south BNSF crosses an east-west Missouri and Northern Arkansas (“MNA”) track using a full flange bearing lift frog crossover structure. The site featured a variety of adjacent structures that influenced the installation of the radar devices as well as the remote access network necessary to collect performance data and supporting video information.

In the quadrant to the northeast of the crossover stands an abandoned furniture plant. In the Northwest quadrant is a large electric utility substation from which 480VAC transmission lines extended directly over the crossover. An underground culvert spans the area and cuts beneath the BNSF track just south

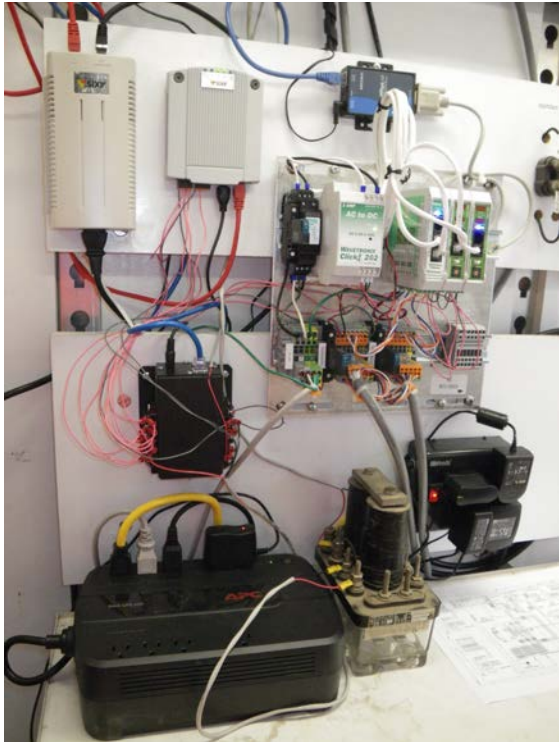
Figure 2 - Radar Controller and Network Components

The radar sensors connect to an electronics controller assembly housed in the equipment bungalow and for data collection purposes were not combined together in order to assess the response from individual radar sensors and the two individual zones that were established – one zone for the north-south BNSF track and the other zone for the east-west MNA track.

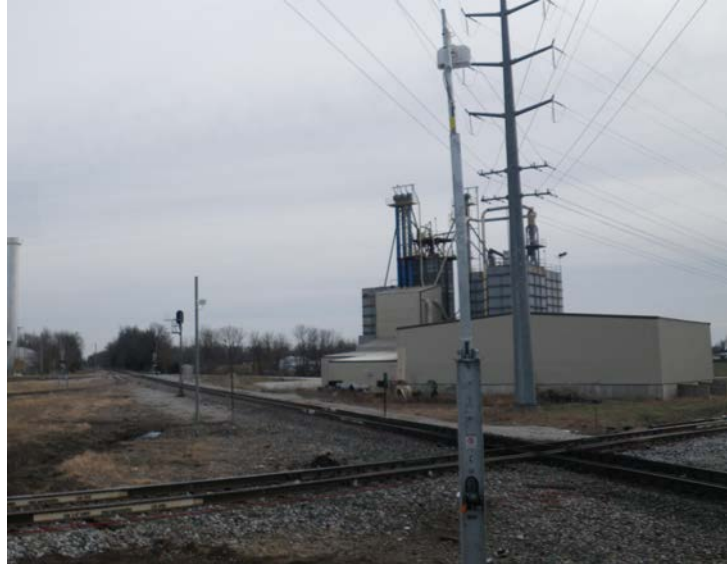
Figure 4 - Actual Radar Locations

The installed radar sensors, combined, provided a complete view of the detection zone from insulator-to-insulator. But neither sensor could be placed at an optimum location where it would have had a complete view of the entire detection area circumscribing all four track approaches to the crossover structure.

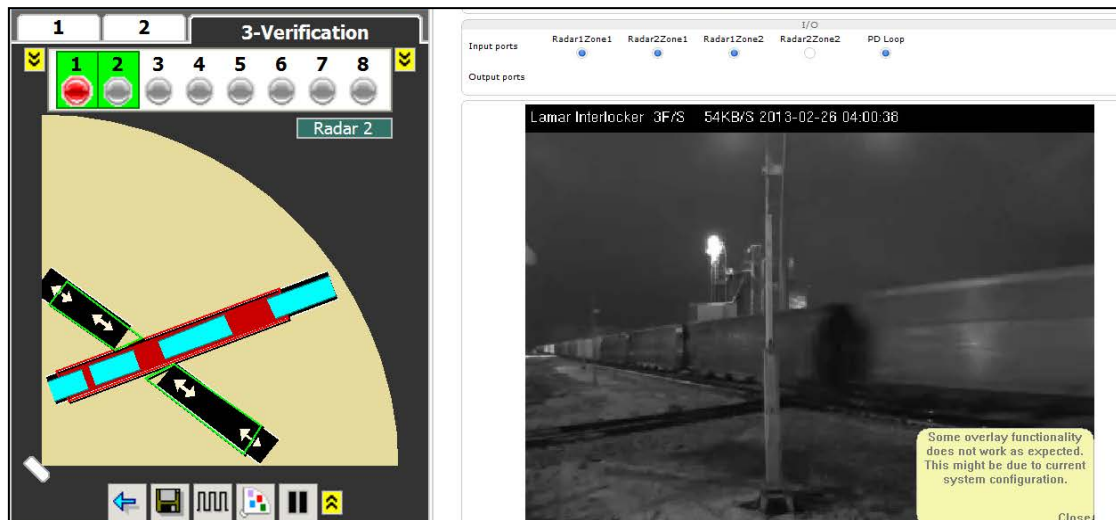
The pattern of return emissions extending in the 'Z' direction away from the radar sensor is a result of a stroboscopic effect of the gap between contiguous railroad cars. The third panel on the bottom of the composite photo shows the detection result along with moving icons representing the train as it has been classified by the radar sensor #2.

Figure 7 - Visual Train Presence Event (right) and Radar Interpretation (left)
